**Wychert Wall Grant Policy**  
**Resolved by the Council March 2023**  
**Reviewed December 2025**  
**Review due December 2028**

## How to look after your witchert building

### What is witchert?

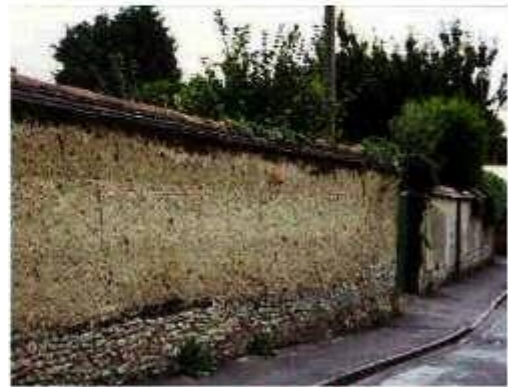
*Witchert wall showing three berries above the grumplings. The coping is formed from plain and half round tiles.*

The walls are constructed as follows. A plinth of rubble stones, known locally as 'grumplings' or 'grumblings', is constructed. This is essential to prevent rising damp and to allow penetrating rain to soak away freely. The taller the grumplings the better the protection from splash-back and surface water.

The well-prepared witchert is put onto the stone foundation in layers, known as berries, of about 0.45 m (18") or more along its length and left to dry before the next berry is added. The sides are trimmed with a sharp spade. The walls may then be rendered for decorative purposes, but garden walls are usually left without a coating and do very well.

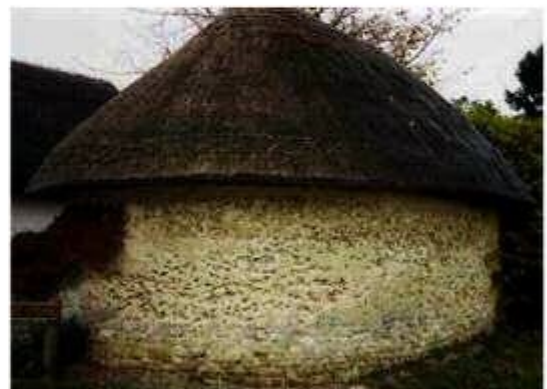
*Small thatched witchert stable, the walls are pockmarked by masonry bees, but remain sound and dry under the overhanging thatch and above the unaltered stone plinth*

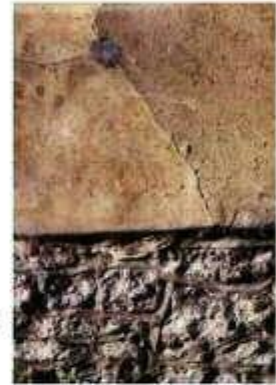
*Cement mortar pointed grumplings and cement render. Cracks in both are drawing in water through capillary action. The moisture is unable to escape through dense render and cement mortar.*

- Concrete floor which forces moisture up into the walls;
- Cracked cement renders. Even hair-line cracks attract and trap moisture through capillary action;
- Failed roof coverings, which expose the top of the walls;
- Failed flashings around chimneys.

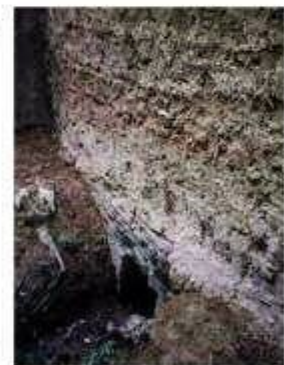
*Newly rebuilt witchert wall over stream before trimming.*
