Wychert Wall Grant Policy
Resolved by the Council March 2023
Due for review March 2025

How to look after your witchert building

What is witchert?

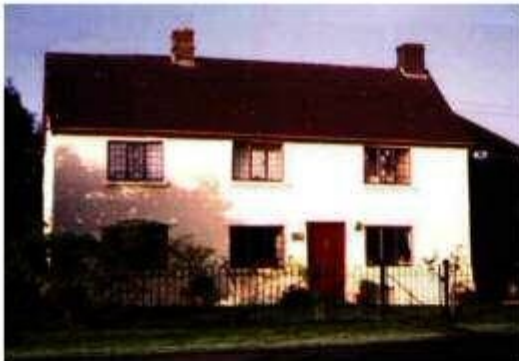
An early 19th century witchert house in Grendon Underwood, recently lime-rendered and lime washed after its pebble-dash had been removed.

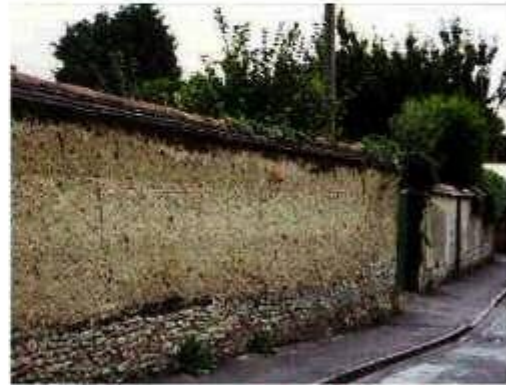
Witchert wall showing three berries above the grumplings. The coping is formed from plain and half round tiles.

The walls are constructed as follows. A plinth of rubble stones, known locally as 'grumplings' or 'grumblings', is constructed. This is essential to prevent rising damp and to allow penetrating rain to soak away freely. The taller the grumplings the better the protection from splash-back and surface water.

The well-prepared witchert is put onto the stone foundation in layers, known as berries, of about 0.45 m (18") or more along its length and left to dry before the next berry is added. The sides are trimmed with a sharp spade. The walls may then be rendered for decorative purposes, but garden walls are usually left without a coating and do very well.

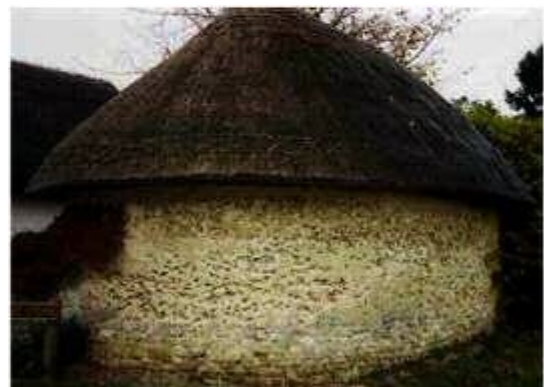
Small thatched witchert stable, the walls are pockmarked by masonry bees, but remain sound and dry under the overhanging thatch and above the unaltered stone plinth

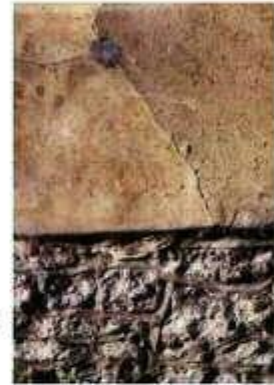
Cement mortar pointed grumplings and cement render. Cracks in both are drawing in water through capillary action. The moisture is unable to escape through dense render and cement mortar.

- Concrete floor which forces moisture up into the walls;
- Cracked cement renders. Even hair-line cracks attract and trap moisture through capillary action;
- Failed roof coverings, which expose the top of the walls;
- Failed flashings around chimneys.

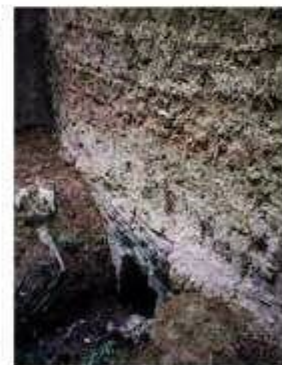
Newly rebuilt witchert wall over stream before trimming.

Repairs to witchert walls need to be carried out using earth materials. Sound witchert can be reconstituted or freshly dug from the ground and applied in berries when wet. Alternatively the material can be shaped into blocks, allowed to dry and used like bricks with a witchert slurry as mortar.
