Witchert Wall Grant Policy
Resolved by the Council on 5th November 2018
Due for review November 2021

What is witchert?

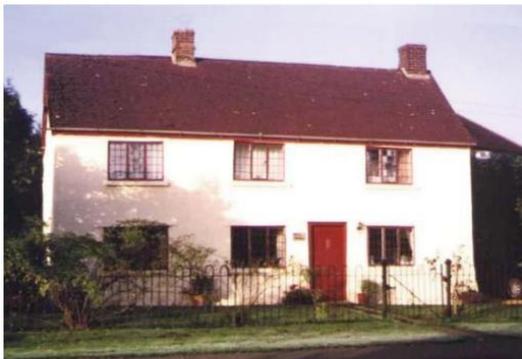
An early 19th century witchert house in Grendon Underwood, recently lime-rendered and lime washed after its pebble-dash had been removed.

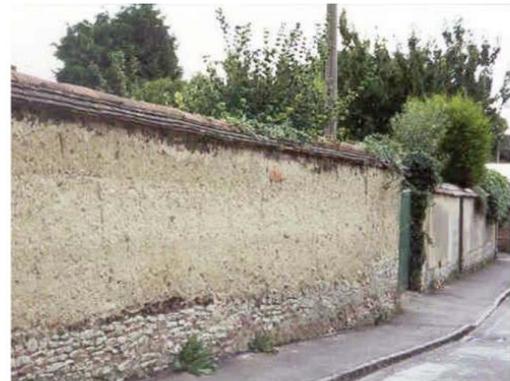
Witchert wall showing three berries above the grumplings. The coping is formed from plain and half round tiles.

The well-prepared witchert is put onto the stone foundation in layers, known as berries, of about 0.45 m (18") or more along its length and left to dry before the next berry is added. The sides are trimmed with a sharp spade. The walls may then be rendered for decorative purposes, but garden walls are usually left without a coating and do very well.

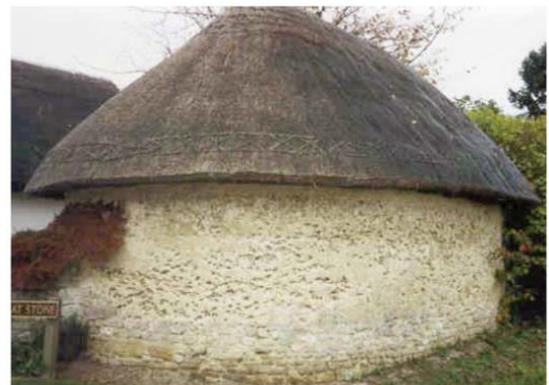
Small thatched witchert stable, the walls are pockmarked by masonry bees, but remain sound and dry under the overhanging thatch and above the unaltered stone plinth

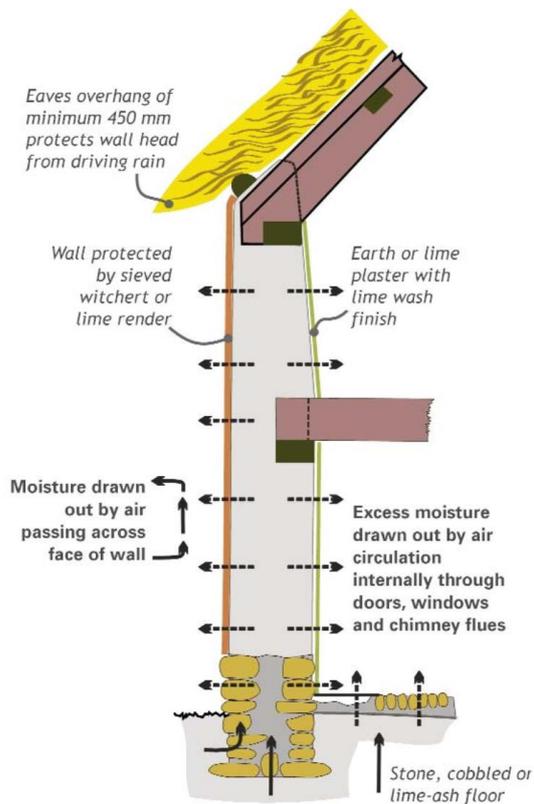
Figure 1A Wall of unaltered earth building showing how a state of moisture equilibrium is achieved

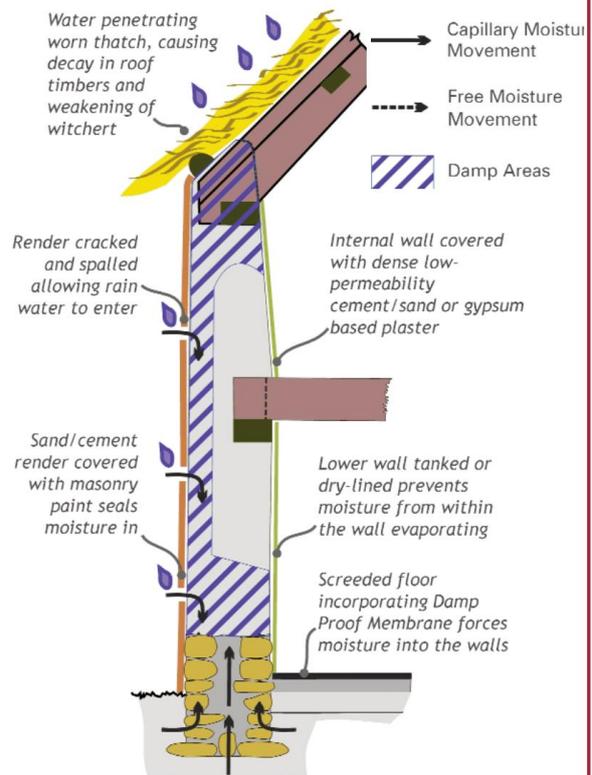
Figure 1B Neglect combined with inappropriate repair/maintenance can upset the balance by retaining moisture within the walls and lead to rapid deterioration

Cement-rich renders and dense plasters, coated in impervious paints, create strait-jackets, which stop buildings from breathing, trap moisture and prevent early detection of trouble caused by decay of the binding material. A prolonged, high moisture content can create conditions which will wash out the fines and may rot the straw. Moisture allows the build up of soluble salts, which in turn breaks down the materials, transforming the non-shrinkable clays into fine shrinkable clay. This

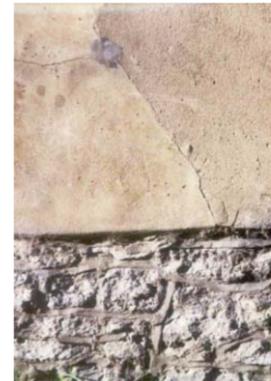
Cement mortar pointed grumplings and cement render. Cracks in both are drawing in water through capillary action. The moisture is unable to escape through dense render and cement mortar.

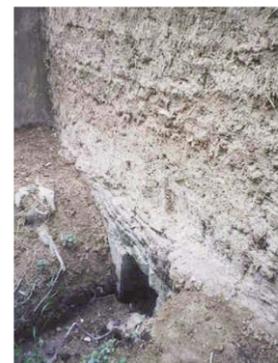
Newly rebuilt witchert wall over stream before trimming.
